Bear Hollow Inspections

Property Inspection Report

Date of Inspection: 12/27/2017 Time: 0900
Age of Home: 63 yrs Size: 1074 sqft

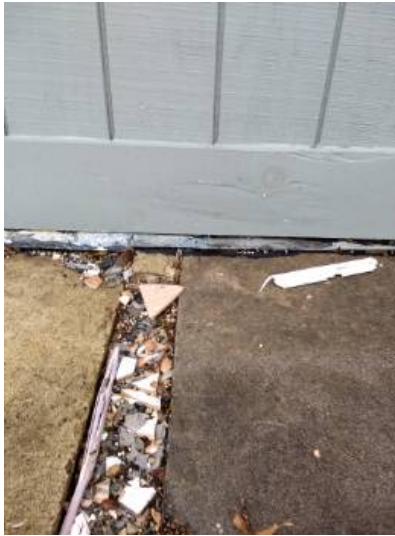
- Converted garage does not have the proper slab offset and grading to avoid water infiltration at the wall base.

Foundation at converted garage does not provide proper offset to avoid water infiltration

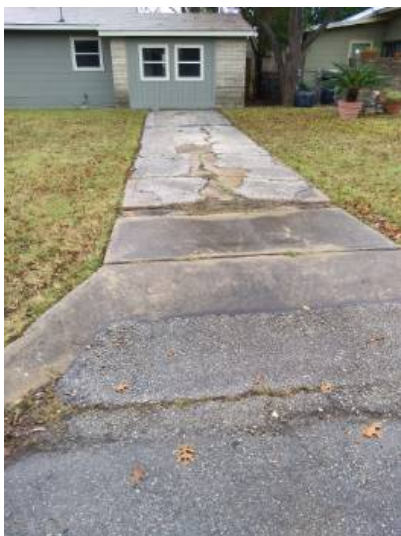
Driveway surface cracked and uneven

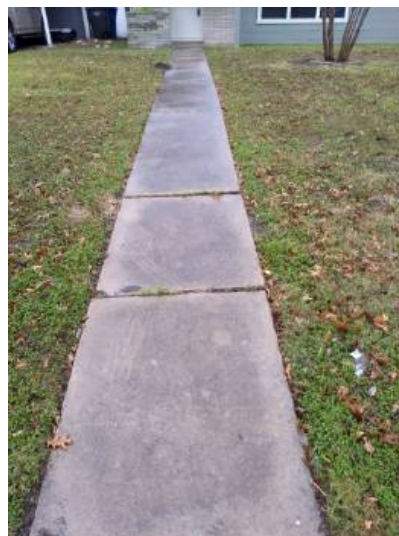
Sidewalk cracked and uneven

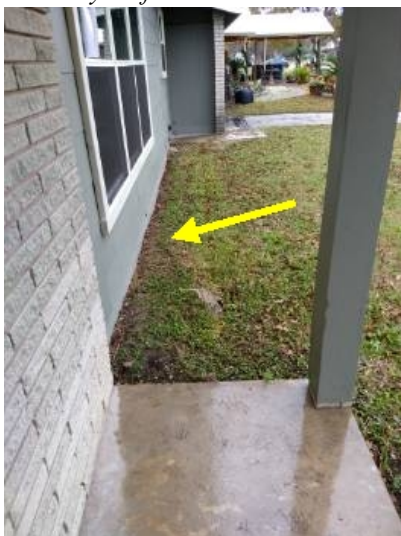
- Trees too close to structure
- It was observed that the current drainage was directed towards the house and should slope away from the foundation a minimum of {6"} in a {10'} span
- No gutter systems were observed and should be considered
- Grade level at or above the sill plate level and should be corrected

Grading slopes toward house

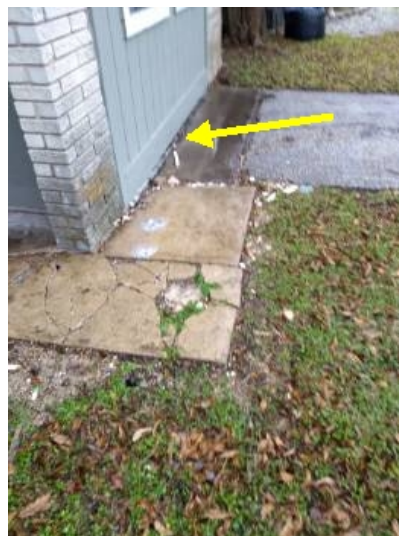
Grading slopes toward house

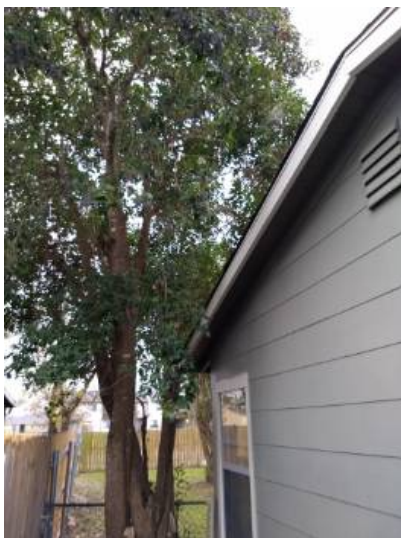
Vegetation contact with roof

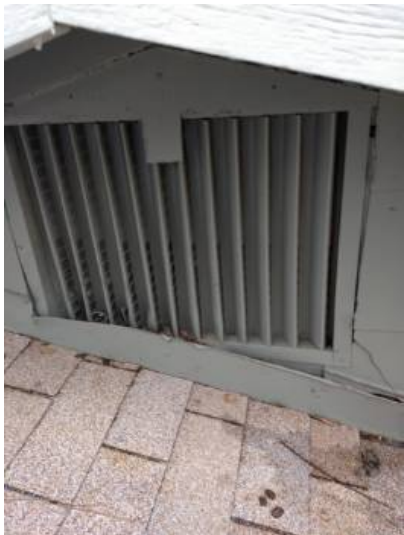
Gable vent installed improperly

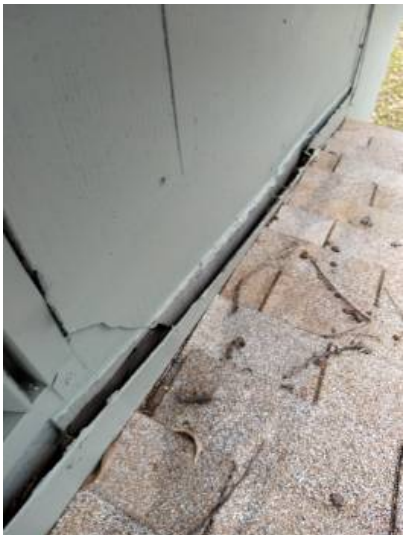
Flashing separating from wall

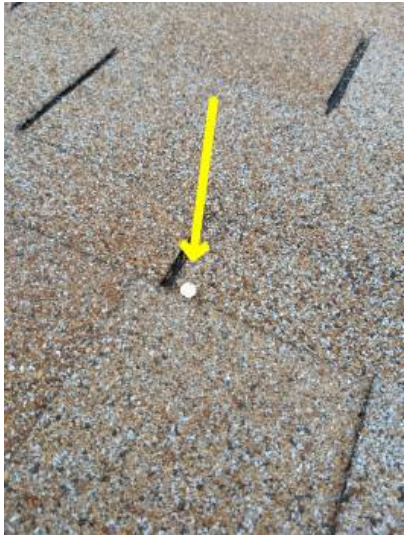
exposed nail in roofing should be caulked

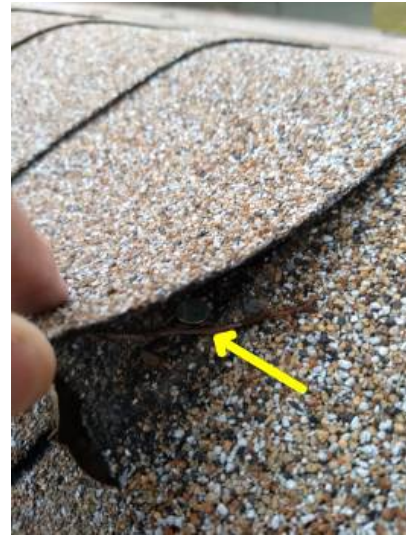
roof nails need to be properly seated under ridge cap

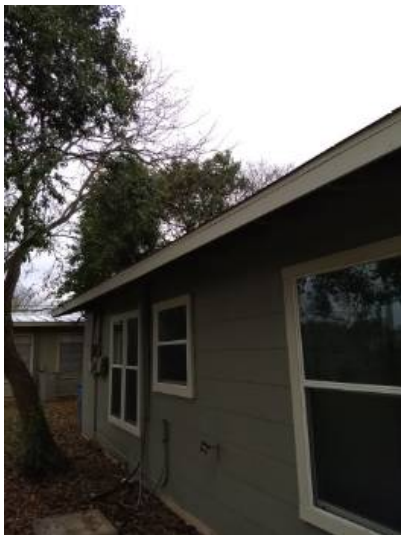
No guttering found on house

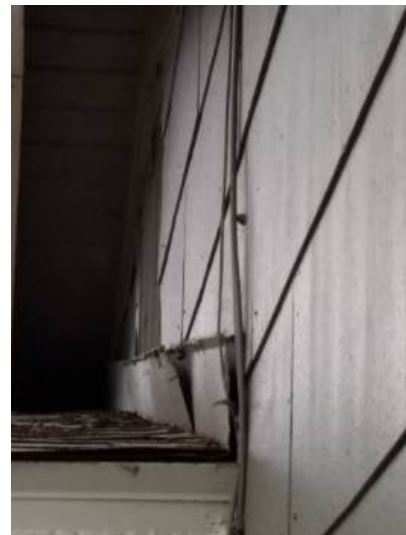
Flashing separating from house at roof junction

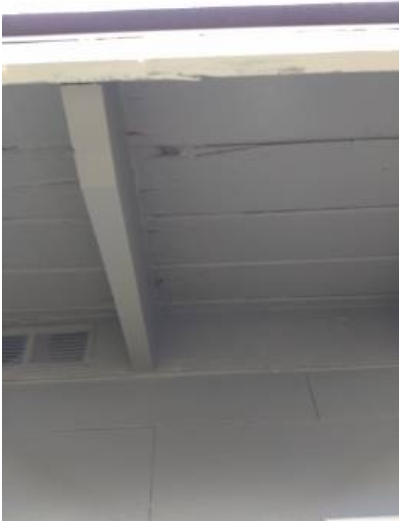
*Minor rot to roof decking at eave*

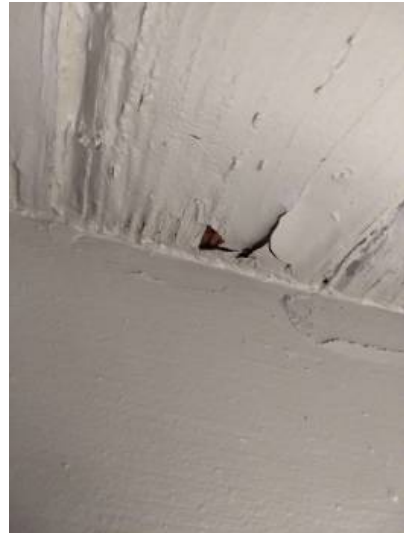
*Slight rot found at soffit*

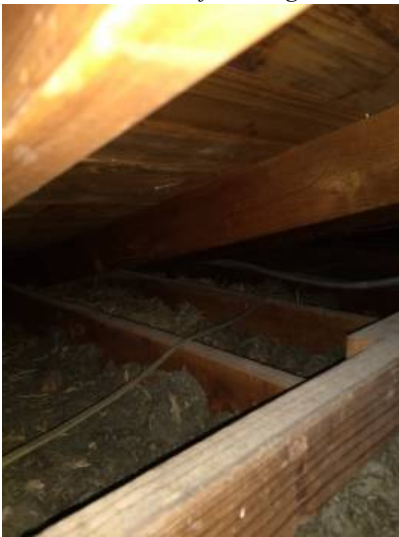
*Very low level of insulation in attic*

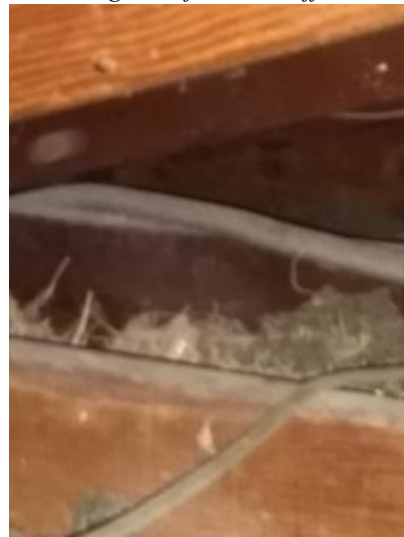
*Evidence of pests in attic*

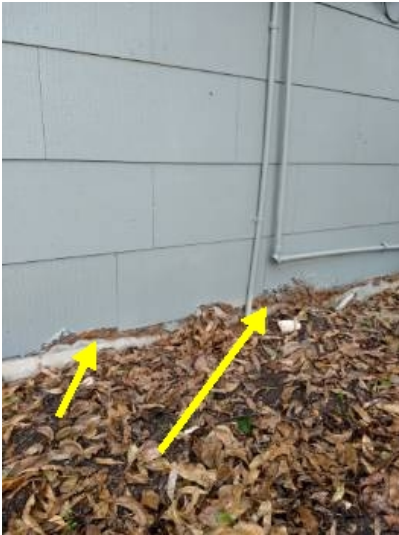
Damage to exterior siding at foundation

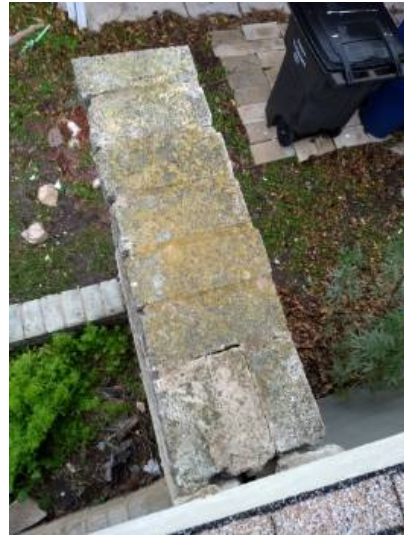
Exposed wall should be properly covered to avoid water infiltration into house

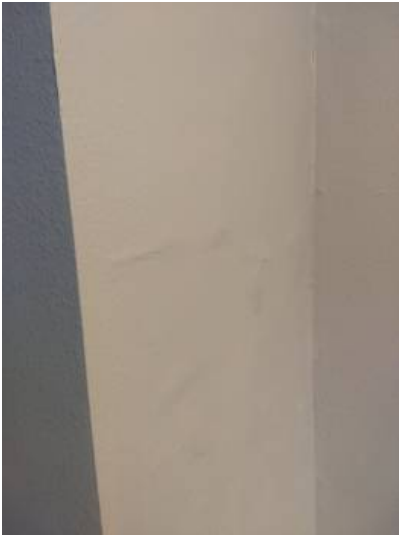
Patched drywall damage in living room

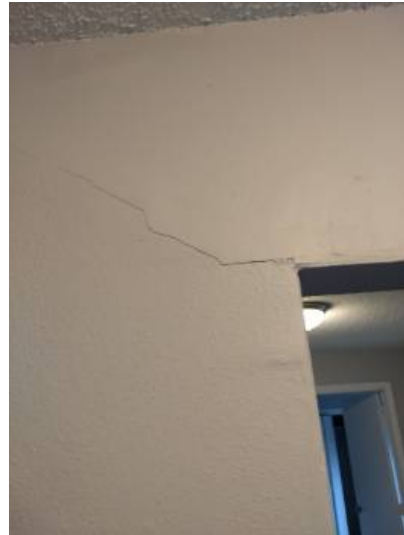
Settlement cracking at door openings

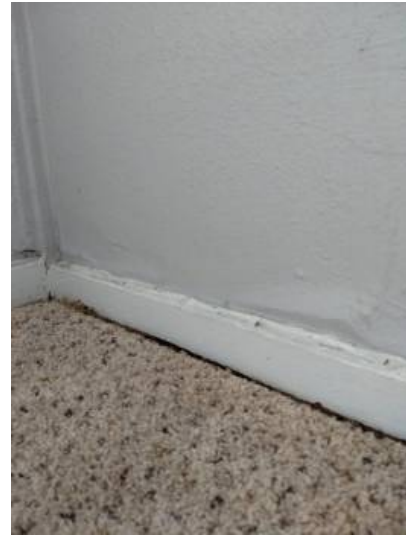
Rot at baseboard in converted garage.

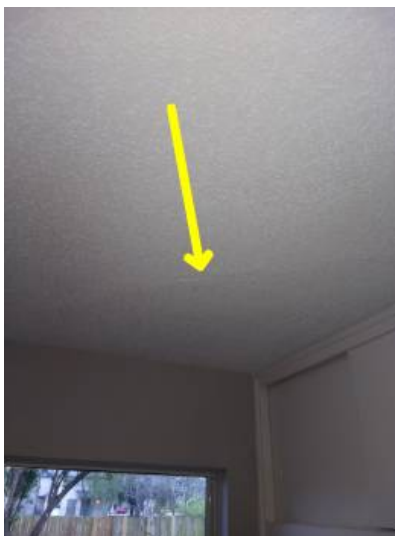
Drywall crack and sagging in bedroom

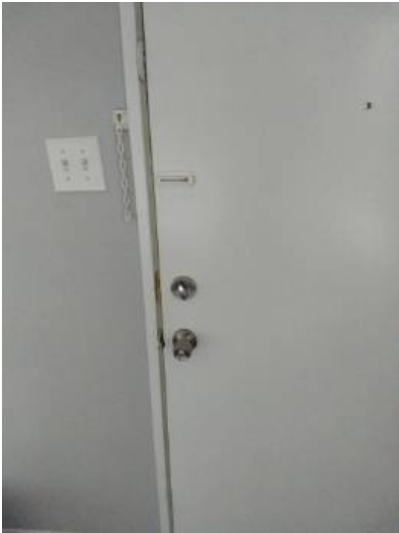
Front door deadbolt operates but does not seat in strike plate.

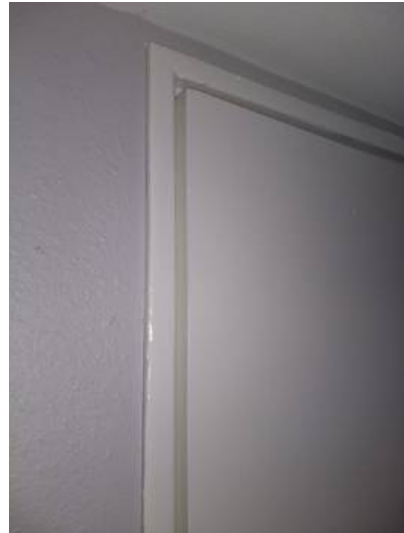
Doors sticking in multiple locations

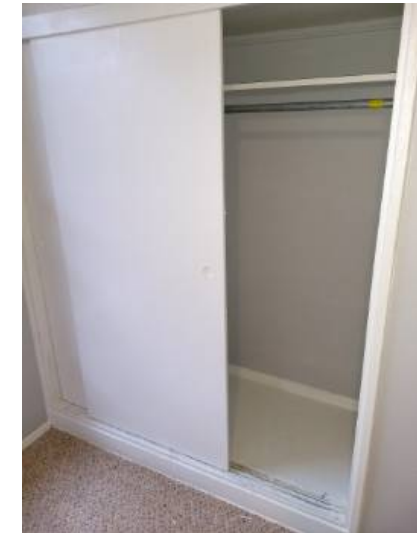
Bypass closet doors difficult to operate.

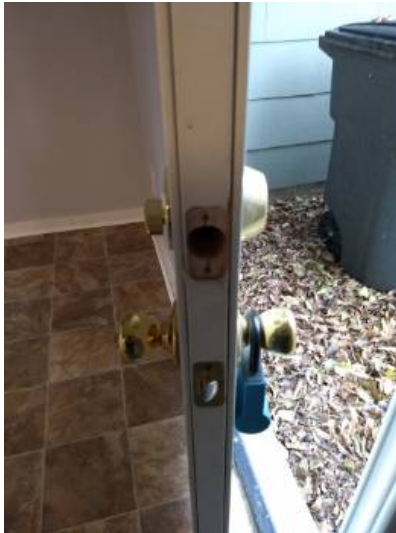
Missing parts on rear door deadbolt

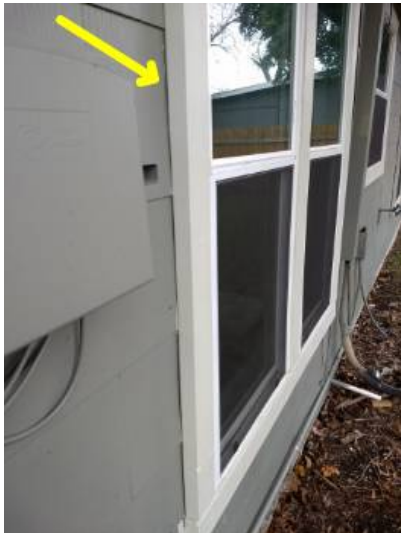
Window trim needs caulking

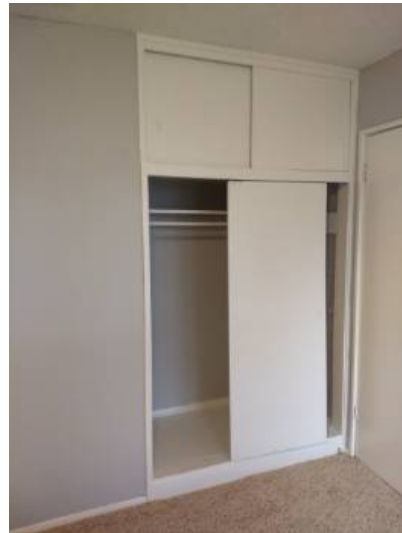
Missing closet door

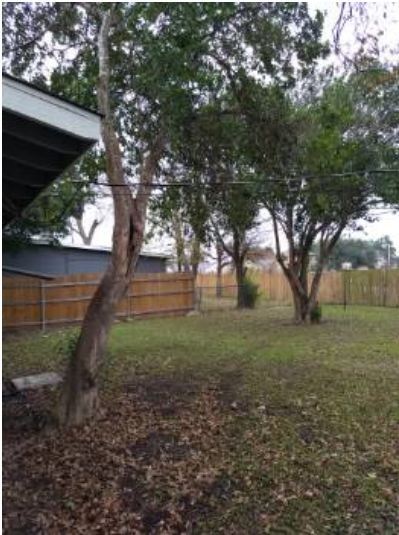
- Service entrance wiring is overhead
- The service panel is NOT completely and/or properly labeled. All breakers must be specifically identified as to appliances, lighting and receptacles
- The service panel did not have a main breaker and further evaluation is recommended
- Recommend upgrading the electrical service to meet current standards and ensure safety.
- Service entrance wires over the side or rear yard should be a minimum of {10'} above the ground and {12'} above the driveway. The current overhead service is 8'3" above grade.

*Electric Service 99 in" from grade*

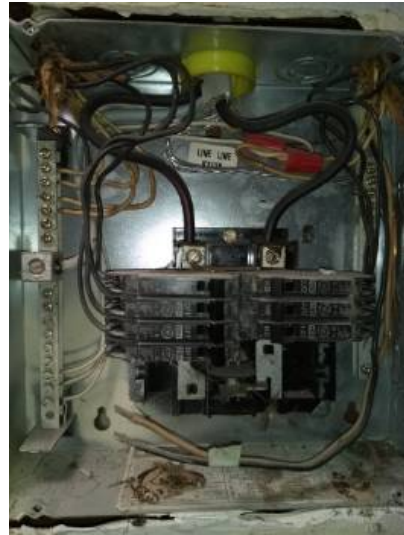
*Sub panel needs evaluation by licensed electrician*

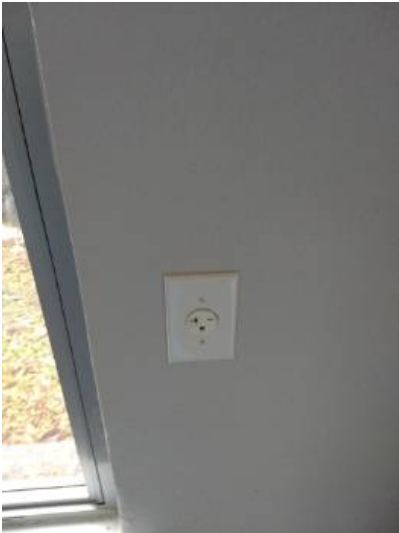
240 volt outlet in living room

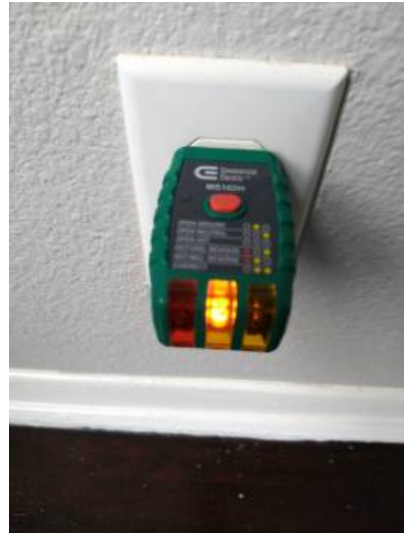
- All appliances should be on individual dedicated circuits
- One or more of the receptacles were noted as an "open ground" and should be corrected

Open ground outlet

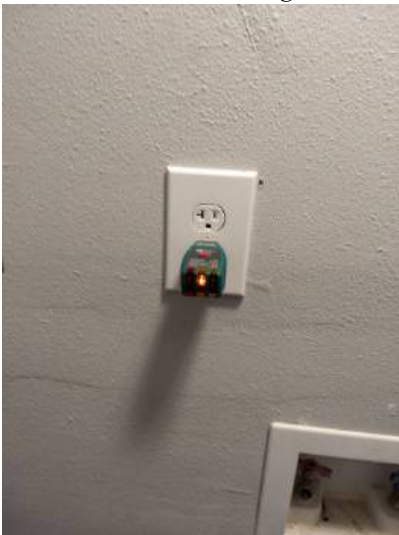
Ungrounded washer outlet

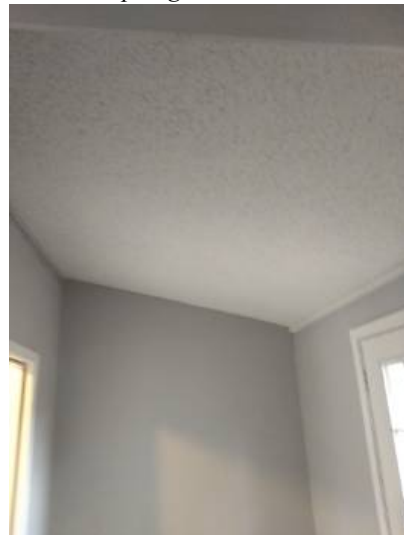
No lighting in rear entryway.

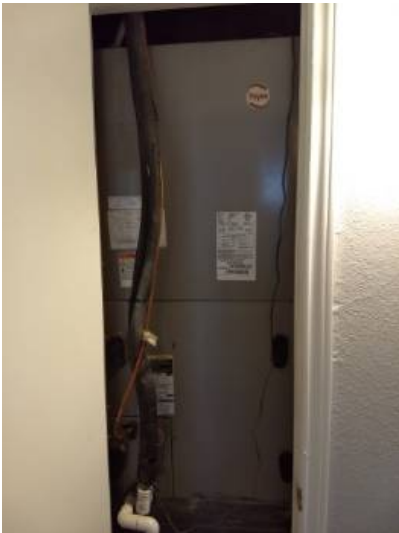
Furnace unit does not have enough clearance to remove.

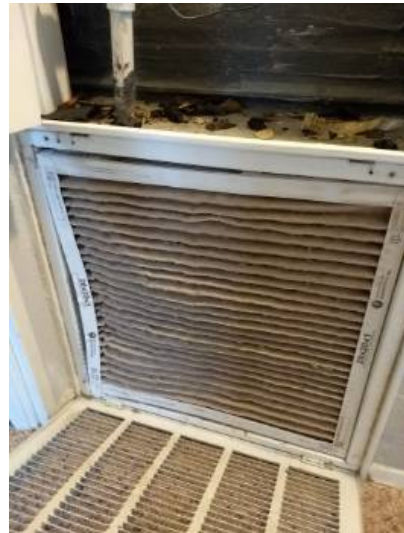
Dirty filter

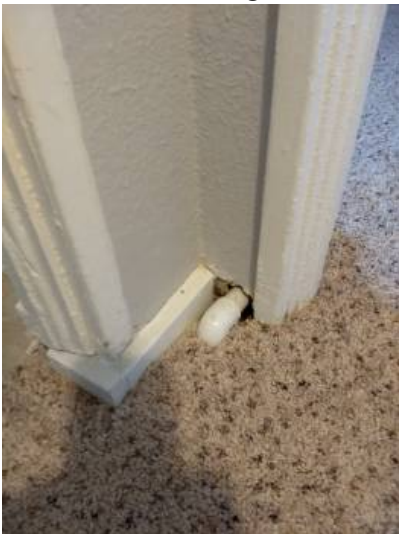
Condensate drain from HVAC runs through hallway

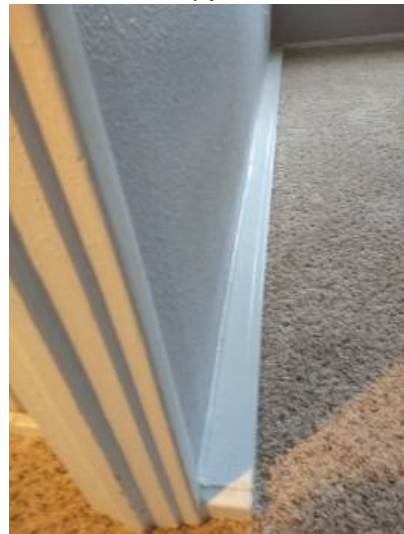
Build out for condensate drain line

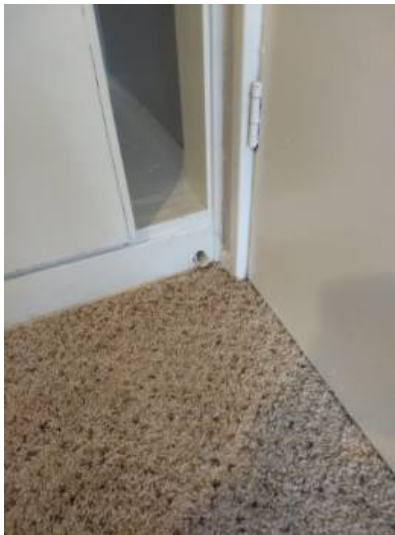
Previous condensate drain line connection

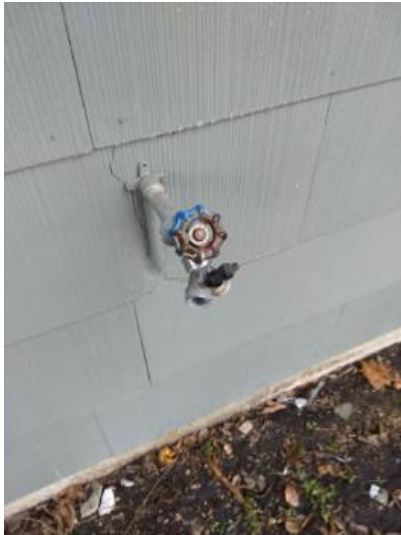
Cannot remove wye from hose bib.

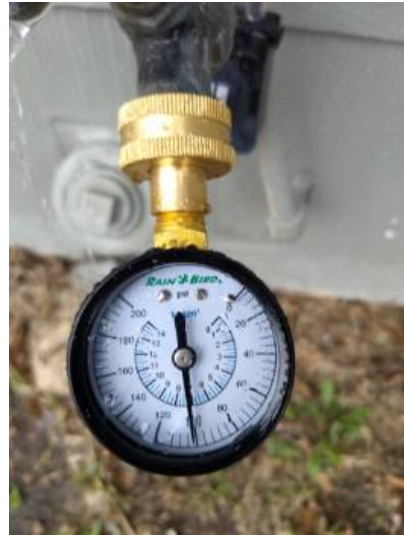
- One or more of the exterior hose bibs {faucets} was observed to be leaking
- The anti static water pressure readings are typically at {40-70 psi} in the normal operating range. Pressure exceeding these limits or higher than {70 psi} is likely to put excessive pressure on the household water system. It is recommended that a licensed plumber and/or the city water department further evaluate in the event a pressure reducing valve is required for safety concerns. The service at this house read 100psi at the exterior hose bib.

100 psi static water pressure

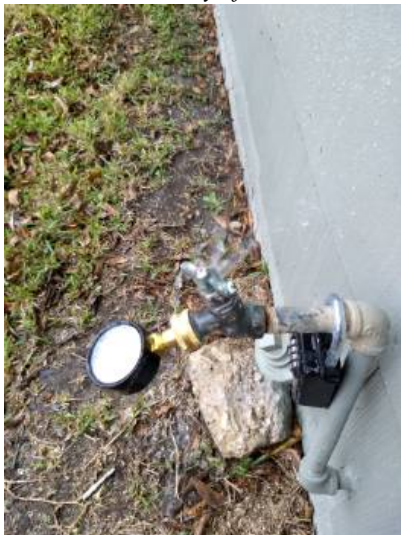
leaking hose bib faucet

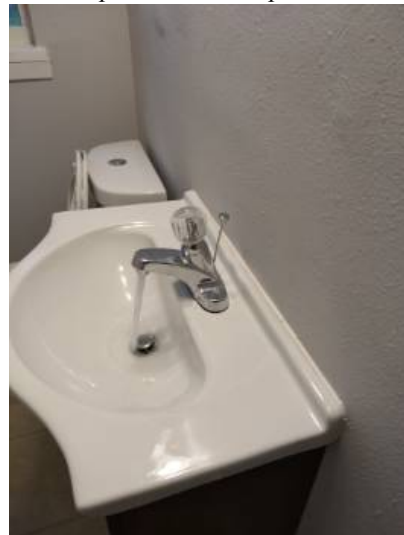
Sink drain plug inoperable

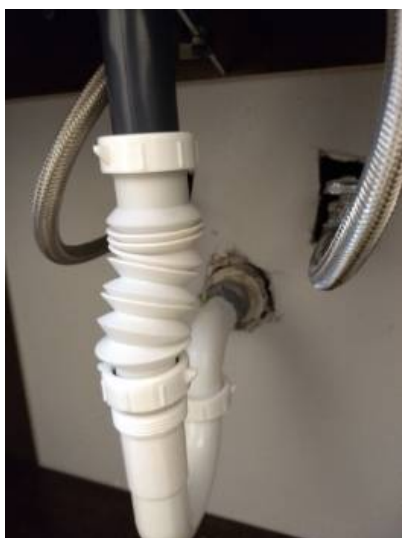
Improper trap and drain connection at vanity

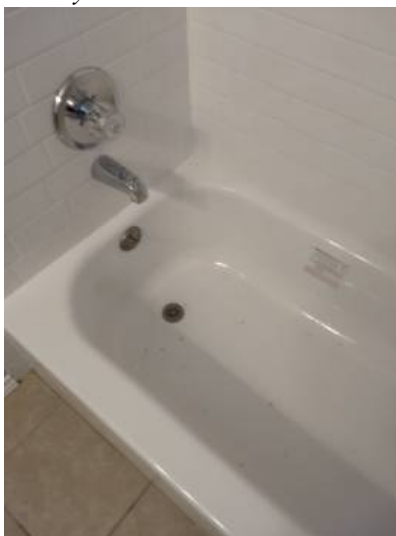
Tub drain did not function properly.

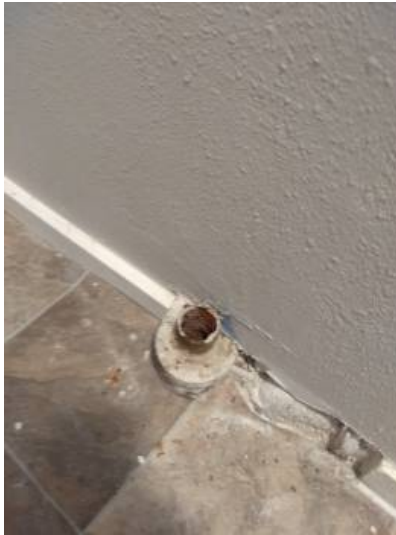
Washer drain at improper height

- Washing machine was observed to have the drain standpipe lower than industry standards which may result in a cross connection in the water supply system. Current standards require the the standpipe at {18"-30"} above the finished floor and the trap at {6"-18"}

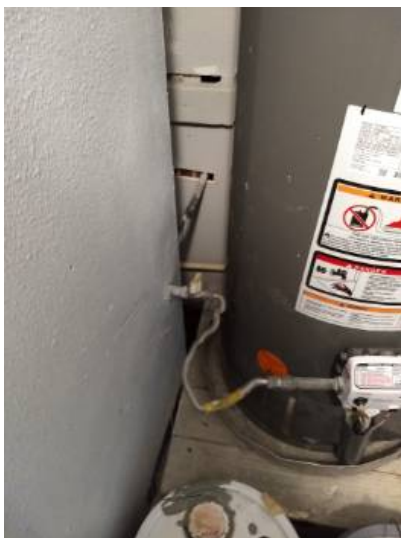
Water heater gas supply was shut off

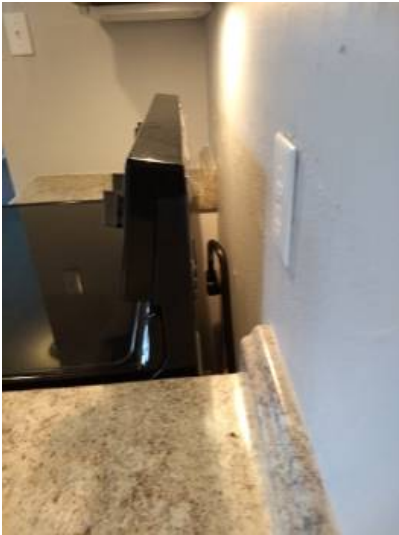
No anti tip device on range.

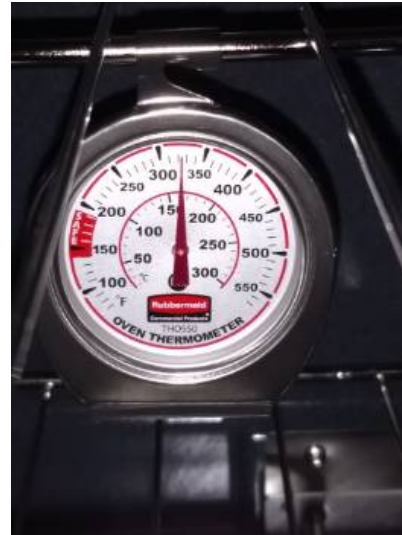
- Oven(s): Electric
- Oven(s) was functional at the time of the inspection
- All heating elements were functional at the time of the inspection
- The oven was tested at {350} degrees for a {20} minute period and was determined to be at 325 deg. which is within accepted range.
- Anti-tip bracket is missing from range installation. All free-standing, slide-in ranges include an anti-tip device and is essential in the safe operation of the range. It provides protection when excess force or weight is applied to an open oven door
- Anti-Tip devices became a UL (Underwriters Laboratories) safety standard requirement in 1991.

Oven 325 deg. set at 350 deg.
